FIG. 2  
THE TENSILE STRENGTH OF CuNiSi AND  
CuSnNiSi SINTERED MATERIALS ( $\sigma_b$ )

THE STRUCTURES OF Cu-Ni-Si BASED SINTERED COMPACTS  
(A MAGNIFICATION OF  $\times 400$ )  
(SINTERING CONDITION  $1100^{\circ}\text{C} \times 1\text{HR}$ )

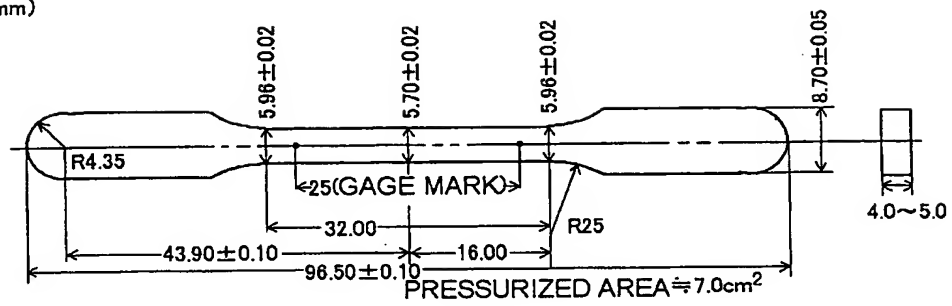
FIG. 1

(UNIT:mm)

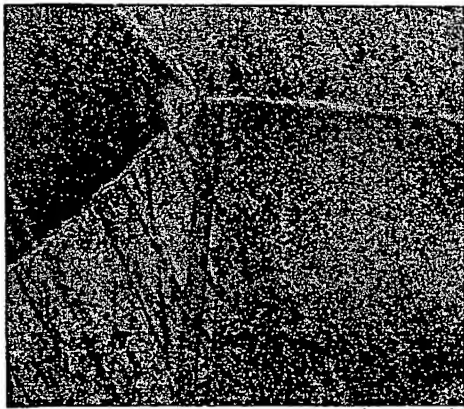
FIG. 3

a) Cu-3Ni-1Si

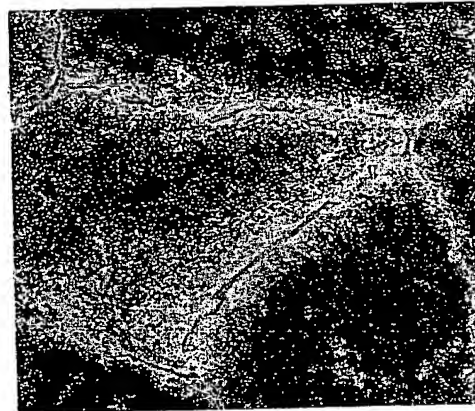
b) Cu-4.5Ni-1.5Si

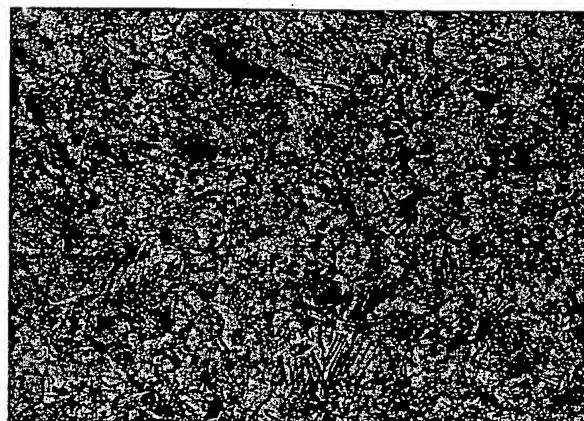
FIG. 6

THE STRUCTURE OF A Cu-10Sn-10Ni-0.55FeP-3Pb (B16)  
BASED SINTERED COMPACT  
(850°C × 1HR)
